Evaluating Roadway Subsurface Drainage Practices

Final Report
May 2013

IOWA STATE UNIVERSITY
Institute for Transportation

Sponsored by
Iowa Highway Research Board
(IHRB Project TR-643)
Iowa Department of Transportation
(InTrans Project 12-428)

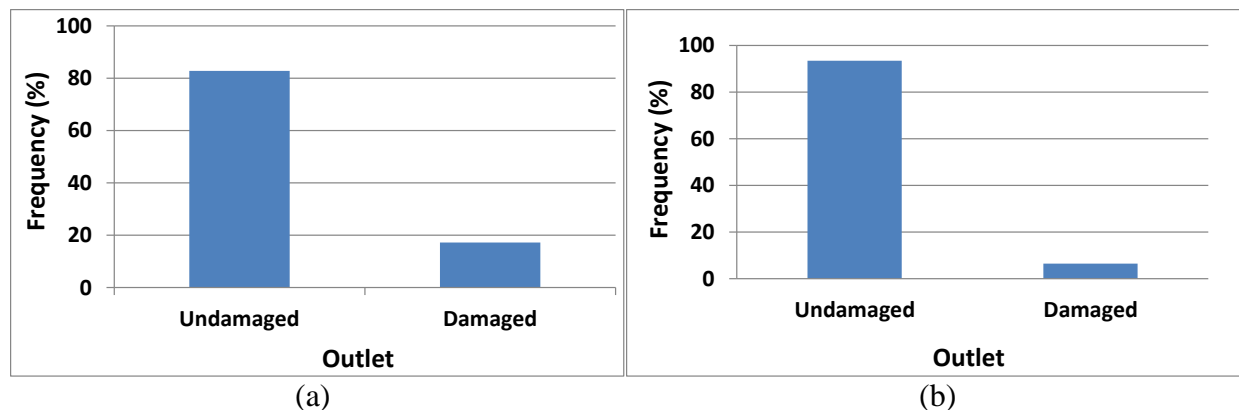
Figure 17 compares undamaged and damaged (broken outlet pipeline) subsurface drainage outlets among the ones that were investigated. Less than 20 percent of the investigated JPCP drainage outlets were damaged while less than 10 percent of HMA pavement drainage outlets were broken.

Figure 17. Undamaged and damaged subsurface drainage outlet in Iowa pavements investigated: (a) JPCP and (b) HMA

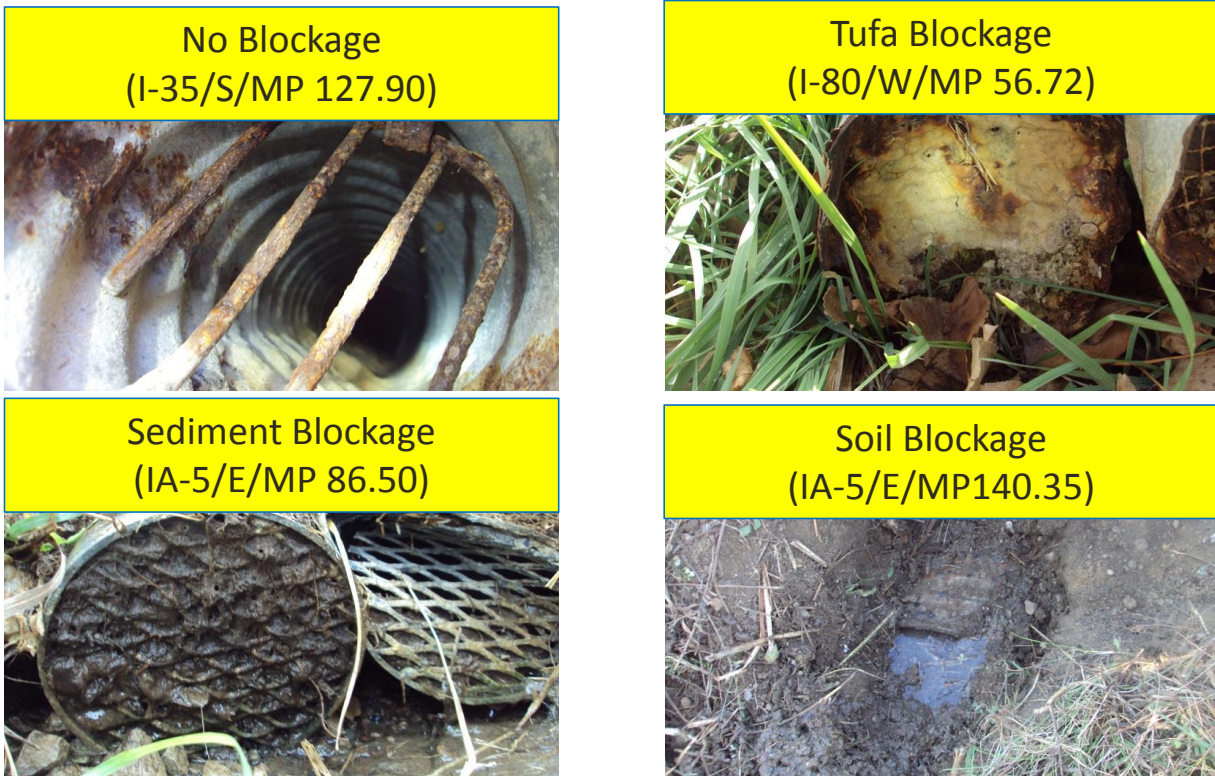
Typical drainage outlet conditions observed during field investigation include the following (see Figure 18):

- No blockage (open)
- Tufa blockage
- Sediment blockage
- Soil/aggregate blockage

No blockage was reported when the inside outlet pipe was in very clean condition. Tufa blockage was reported when there was build-up of calcium carbonate observed either inside the outlet pipe or near rodent guard screens. Tufa blockage was only observed in JPCP containing RPCC base materials. Sediment blockage was reported when dirty or debris materials were deposited inside the outlet pipe or nearby rodent guard screens. Soil blockage was reported when an end of the outlet was not exposed outside but covered by soil or aggregate.

Figure 18. Typical roadway subsurface drainage outlet conditions in Iowa

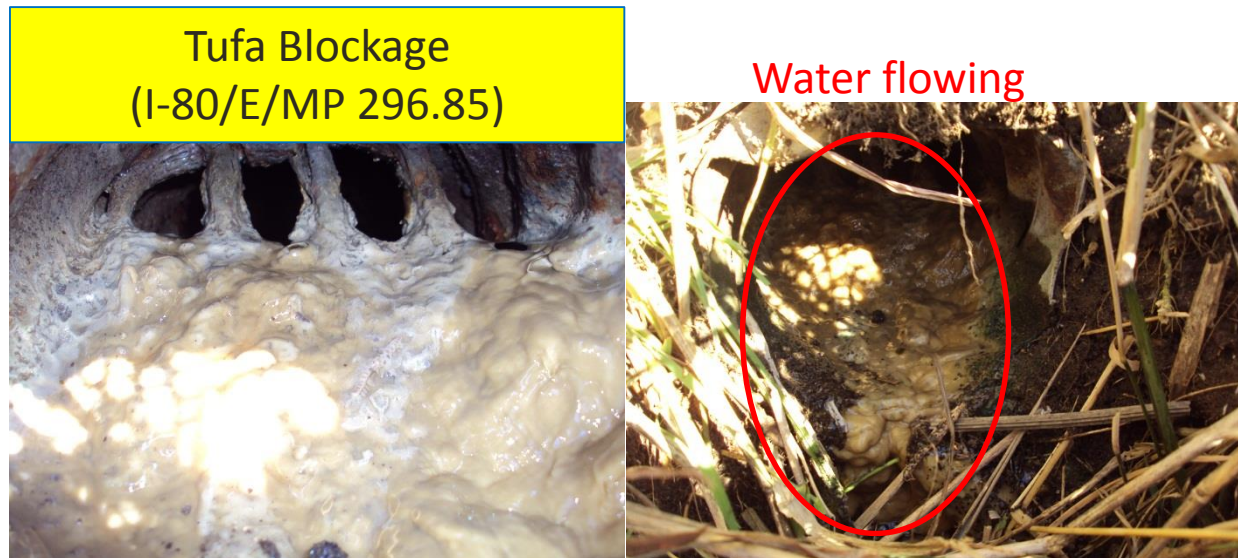
Higher outlet blockage rates lead to slower discharge of water. However, higher blockage rates do not always stop the water from flowing from inside of the outlet pipe to outside of it, as shown in Figure 23, unless the outlet is completely blocked, i.e., 100 percent blockage rate. Note the free flowing drain outlet condition in Figure 23 was not evident at first sight, but was quite clear when viewing the recorded video.

Figure 23. Free water flowing under 75 percent blocked subsurface drainage outlet

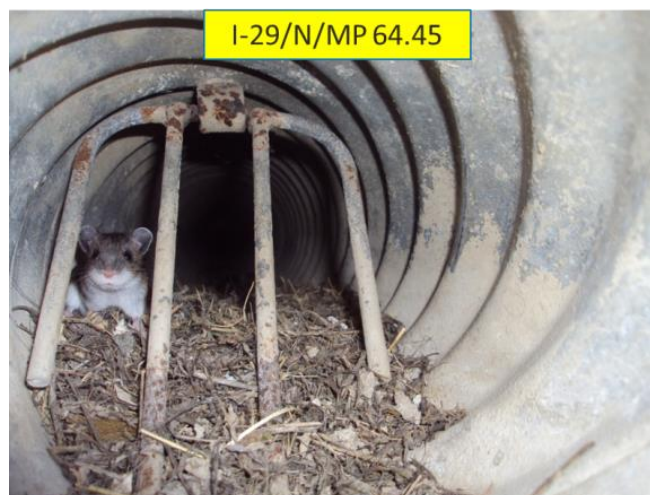
Rodent guards have been used in Iowa pavements to keep mice, rats, and other small rodents from entering subdrains. The two types of rodent guards used in Iowa are mesh screen and fork-shaped ones. Only one drainage spot, as seen in Figure 24, was observed as having rodent evidence.

Figure 24. Rodent evidence inside a subsurface drainage outlet during field investigations

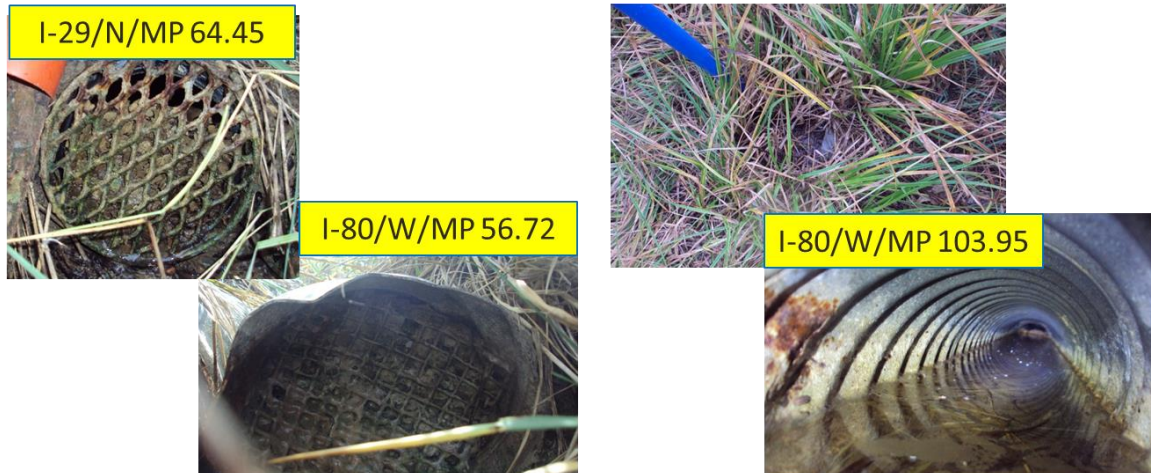
In light of the significant blockage caused by tufa or sediment in many of the investigated drain outlets further complicated by the presence of rodent guards, the question of whether or not we should be using rodent guards has become a moot point. The mesh screen-type rodent guards in some drainage outlets, as shown in Figure 25, is causing clogging with tufa or sediment by filtering the flow of water. Removal of the rodent guards, as shown in Figure 25, often prevents this clogging problem.

Blocked Outlet with Mesh Gate Screen

Opened Outlet without Mesh Gate Screen

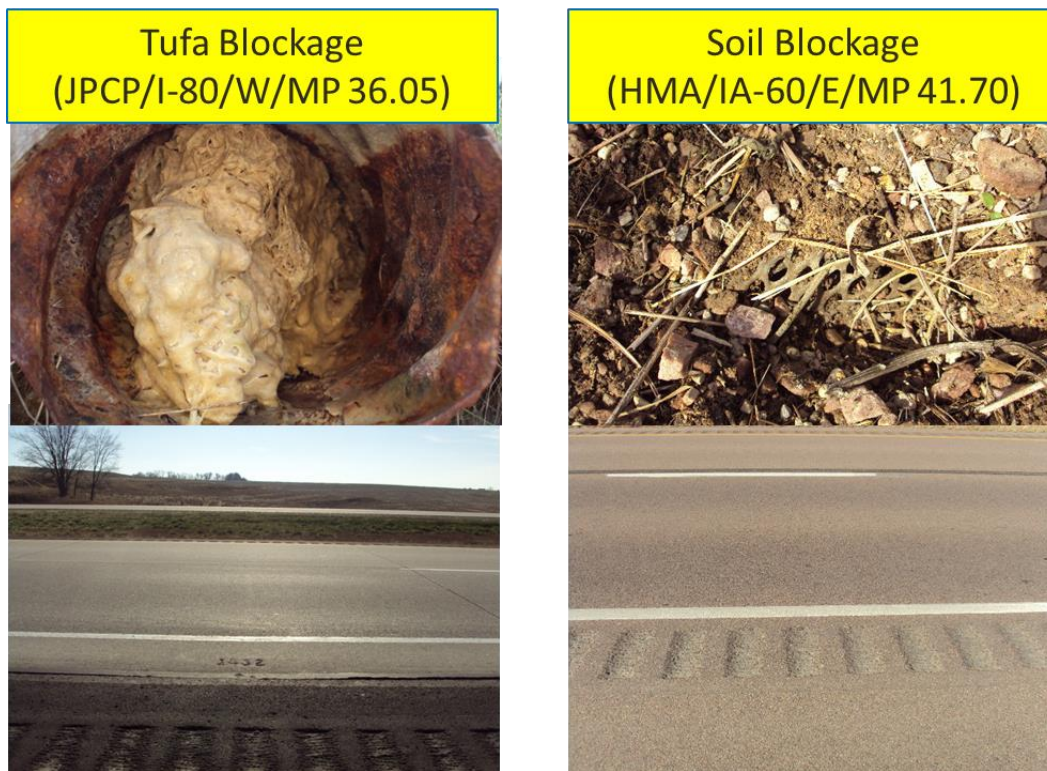
Most surface distresses were observed near open subsurface drainage outlet spots rather than blocked ones. The investigated JPCP sites with blocked outlet spots were constructed from 1990 to 2007 with PCC thicknesses ranging from 9 to 13 in. and AADTT ranging from 579 to 13,264. The JPCP sites with open outlet spots have similar ranges of pavement age, PCC thickness, and AADTT. The investigated HMA sites with both blocked and opened outlet spots were constructed from 1998 to 2006 with HMA thicknesses ranging from 9 to 15 in. and AADTT ranging from 738 to 1,730. As shown in Figure 27, no surface distresses were observed on

blocked outlets in JPCP and little surface distress was observed on blocked outlets in HMA. Only one blocked outlet spot in HMA (US 61/E/MP173.00) had transverse cracking.

JPCP I-80/W/MP 36.05: construction year 2005, AADTT 8,093, PCC thickness 11.5 in.; HMA IA 60/E/MP 41.70: construction year 2006, AADTT 831, HMA thickness 14 in.

Figure 27. No surface distress near blocked subsurface drainage outlet

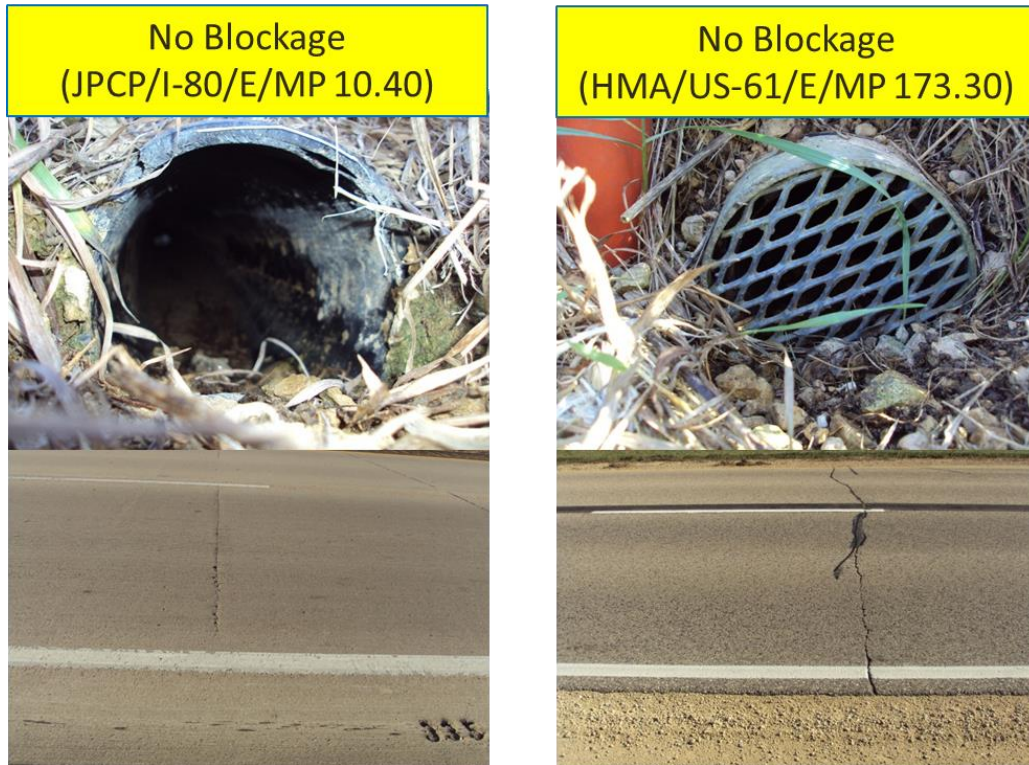
However, open subsurface drainage outlet spots in both pavement types had transverse cracking as shown in Figure 28. Especially note, the opened outlet spot in HMA (US 61/E/MP173.30) in Figure 28 is at a location near to the blocked outlet spot in HMA (US 61/E/MP173.00) that has transverse cracking. Transverse cracking was observed near several culverts (see Figure 29) rather than drainage outlet spots. These results indicate that blocked drainage outlet conditions do not have significant effect on pavement surface distress development.

JPCP I-80/E/MP 10.40: construction year 2003, AADTT 6,825, PCC thickness 12 in.; HMA US 61/E/MP 173.30: construction year 1999, AADTT 1,211, HMA thickness 12 in.

Figure 28. Transverse cracking observed near opened subsurface drainage outlet

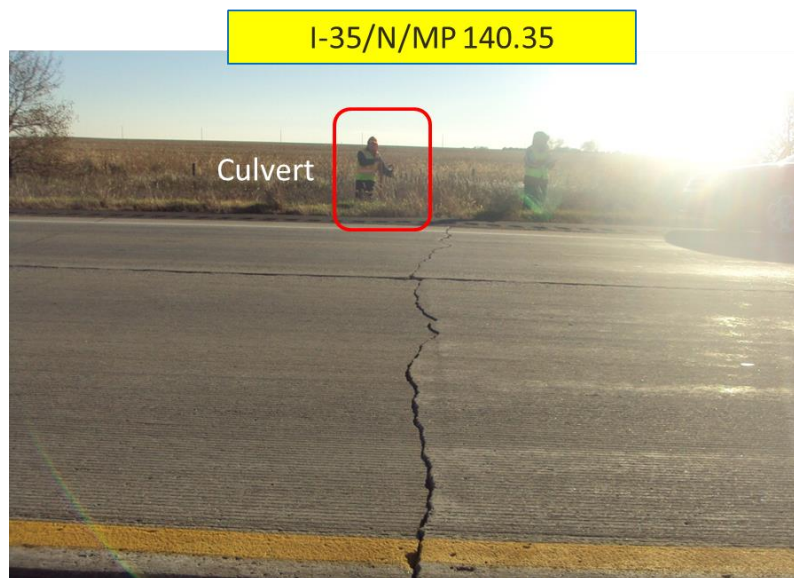
Figure 29. Transverse cracking observed near culvert

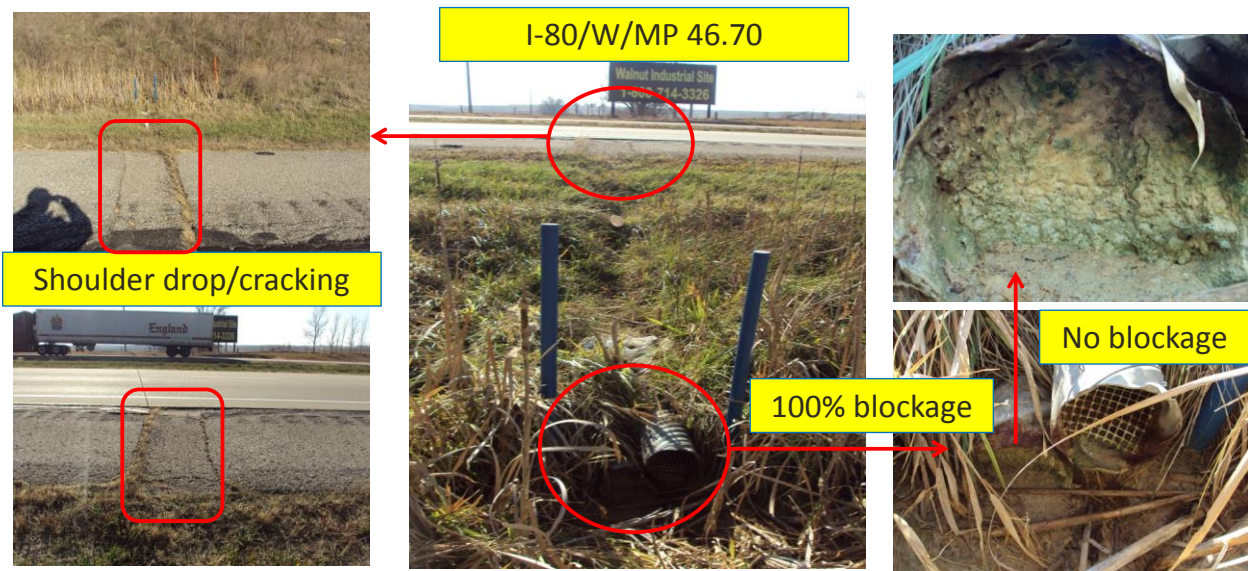
Rather than surface distresses, more shoulder distresses (shoulder drop or cracking) as shown in Figure 30 were observed near blocked drainage outlet spots. Note that the opened outlet captured in Figure 30 was newly installed to replace the 100 percent blocked outlet. Figure 31 compares frequency of outlet spots with observed shoulder distress under opened and blocked outlet conditions. More than 10 percent of the blocked drainage outlet spots have shoulder distresses while only 2 percent among opened drainage outlets have shoulder distresses.

Figure 30. Shoulder drop/cracking observed on blocked outlet in Iowa JPCP
